## AUTOMATIC INTERNAL CARDIAC DEFIBRILLATOR LEAD IN THE LEFT VENTRICLE

SVETLANA BARBARASH, MD

ANN TONG, MD

*(from the Department of Cardiology, Southwest Medical Associates, Las Vegas, Nevada, USA and the Cardiac & Vascular Institute, Gainesville, Florida, USA)*

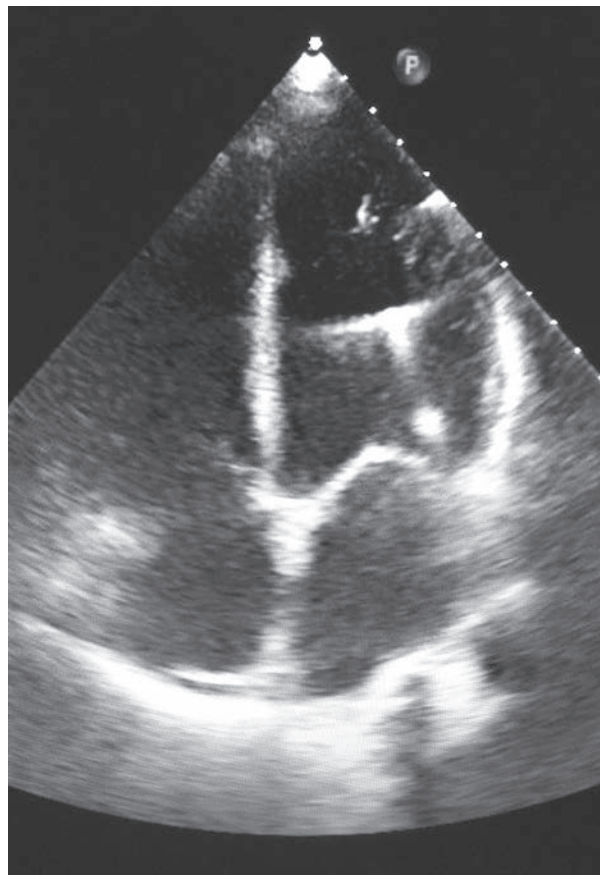
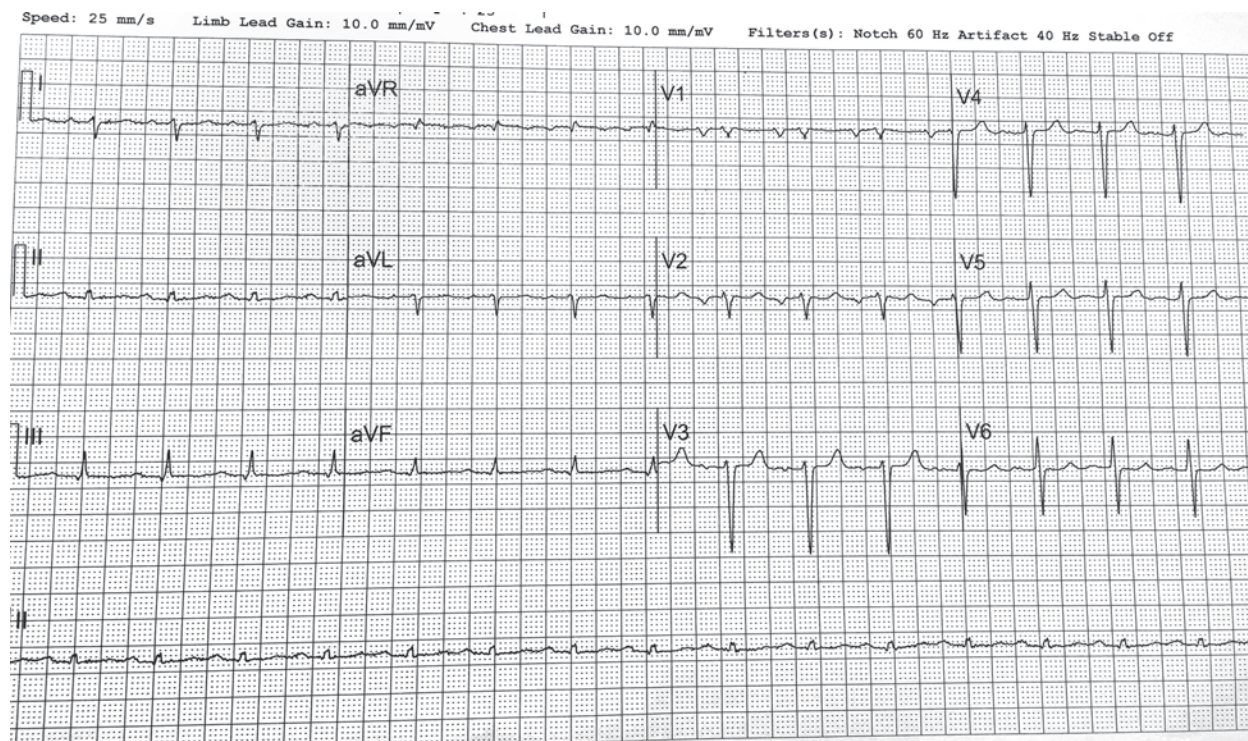
Echocardiogram on 1/11/2016 showed the following: Left ventricle: ICD lead appeared in LV cavity, unclear pathway to determine lead origin (figure 2,3). There was no ICD wire visualized in right-sided cardiac structures. The cavity size was at the upper limits of normal. Systolic function was severely reduced. The estimated ejection fraction was 15-20%. Hypokinesis of the anteroseptum. Akinesis of the inferoseptal, apical, inferior and basal-mid anterolateral myocardium. Anterior wall was not well visualized. Diastolic function could not be evaluated. Right ventricle: moderately dilated, severely hypokinetic. Left atrium: moderately dilated. Pulmonary pressure: systolic pressure was mildly increased.

Transesophageal echocardiogram showed device lead in the ascending aorta through the aortic valve into the left ventricle. The findings were subsequently confirmed by computer tomography of the chest.

On 1/19/2016 the patient underwent surgical lead extraction. Intraoperative findings revealed that the ICD lead was inserted into the left subclavian artery. The lead was retracted under fluoroscopy. The tip was identified and the entire lead was removed from the
